CONDITION SURVEY, LIBERTY ARMY AIRFIELD
FT. STEWART, GEORGIA

**CONDITION SURVEY. LIBERTY ARMY AIRFIELD
FT. STEWART, GEORGIA**

May 1960

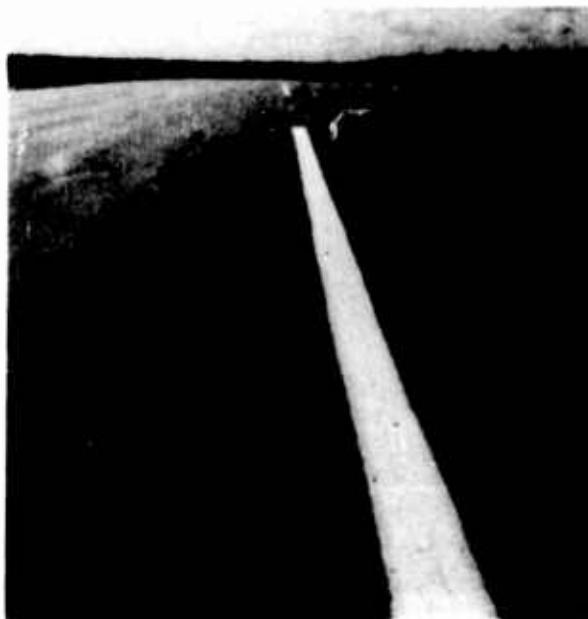
a. General view

Photograph 3. Runway 4 (considered a temporary facility) in June 1967
